The Crisis at Fukushima Dai-ichi Nuclear Power Plant

Prof. Joseph E Shepherd
Aerospace and Mechanical Engineering
California Institute of Technology
Pasadena, CA

April 2011

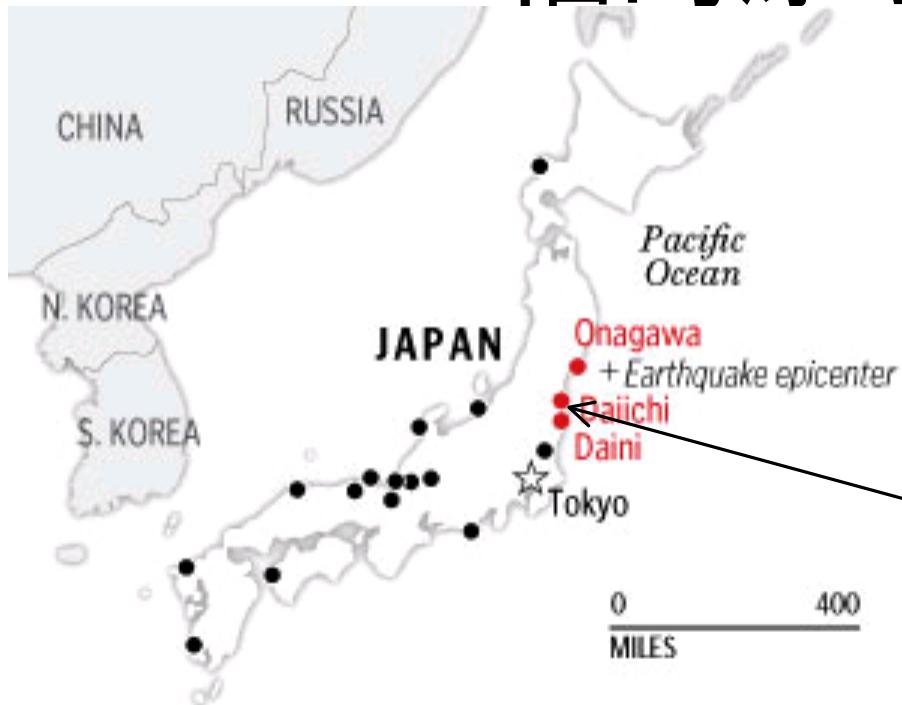
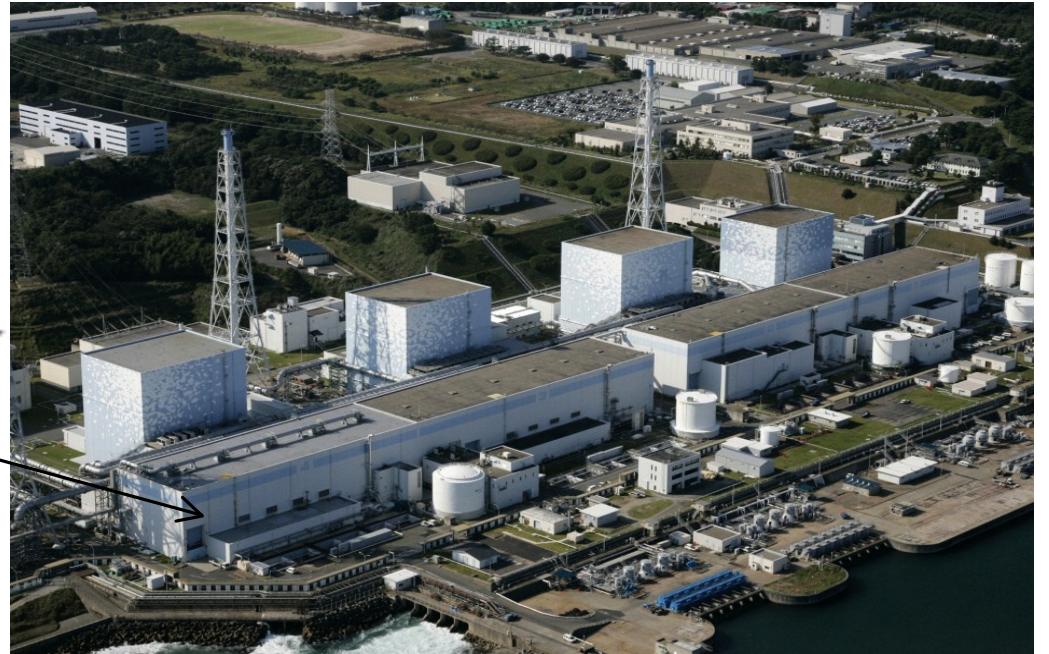
福島原子力発電所

- Fukushima-Daiichi 1, 2, 6 made by GE, rated at 439, 760, 1067 MWe, started up in Nov. 1970, Dec. 1973, May 1979
- Fukushima-Daiichi 3 and 5 made by Toshiba, rated at 760 MWe, started up in Oct. 1974 and September 1977
- Fukushima-Daiichi 4 made by Hitachi, rated at 760 MWe, started up in Feb 1978.
- Fukushima-Daini 1 and 3 made by Toshiba, rated at 1067 MWe, started up in July 1981 and Dec. 1984.
- Fukushima-Daini 2 and 4 made by Hitachi, rated at 1067 MWe, started up in June 1983 and Dec. 1986.

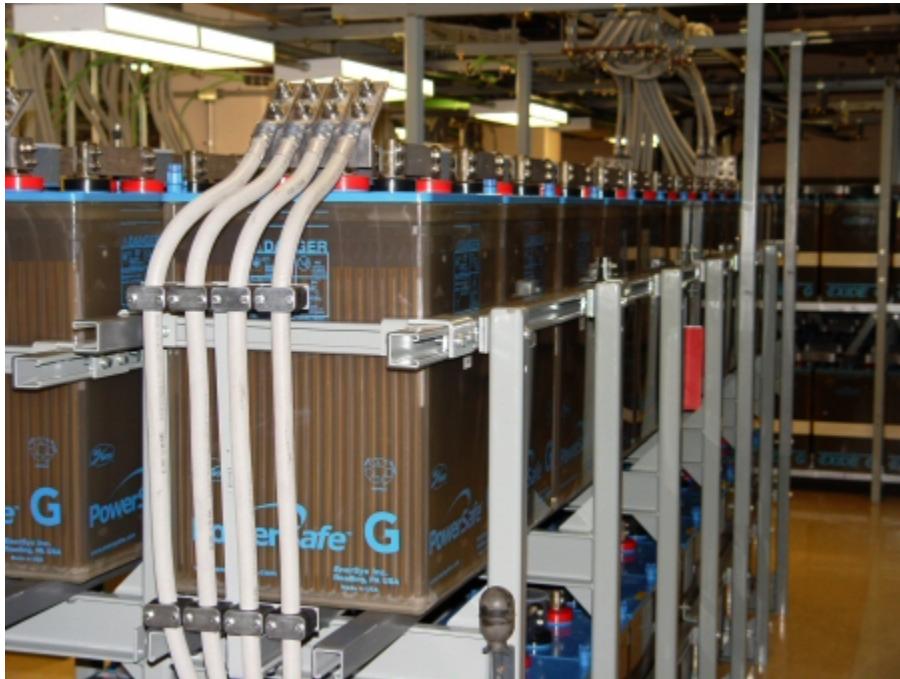
バックアップ電力

Connected to inverters to generate AC power.

Used only to power key instruments and controls.

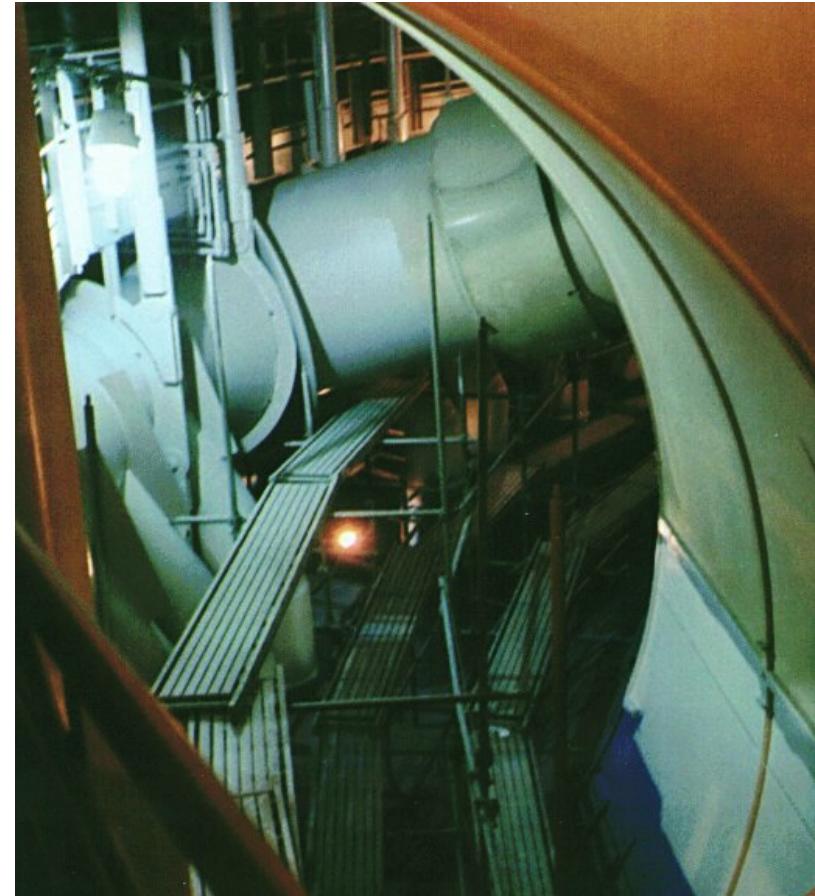
Units 2,3,4 contain 2980 tonne water (1750 for unit 1)

Connected to sphere with vent lines, vacuum breakers for reverse flow

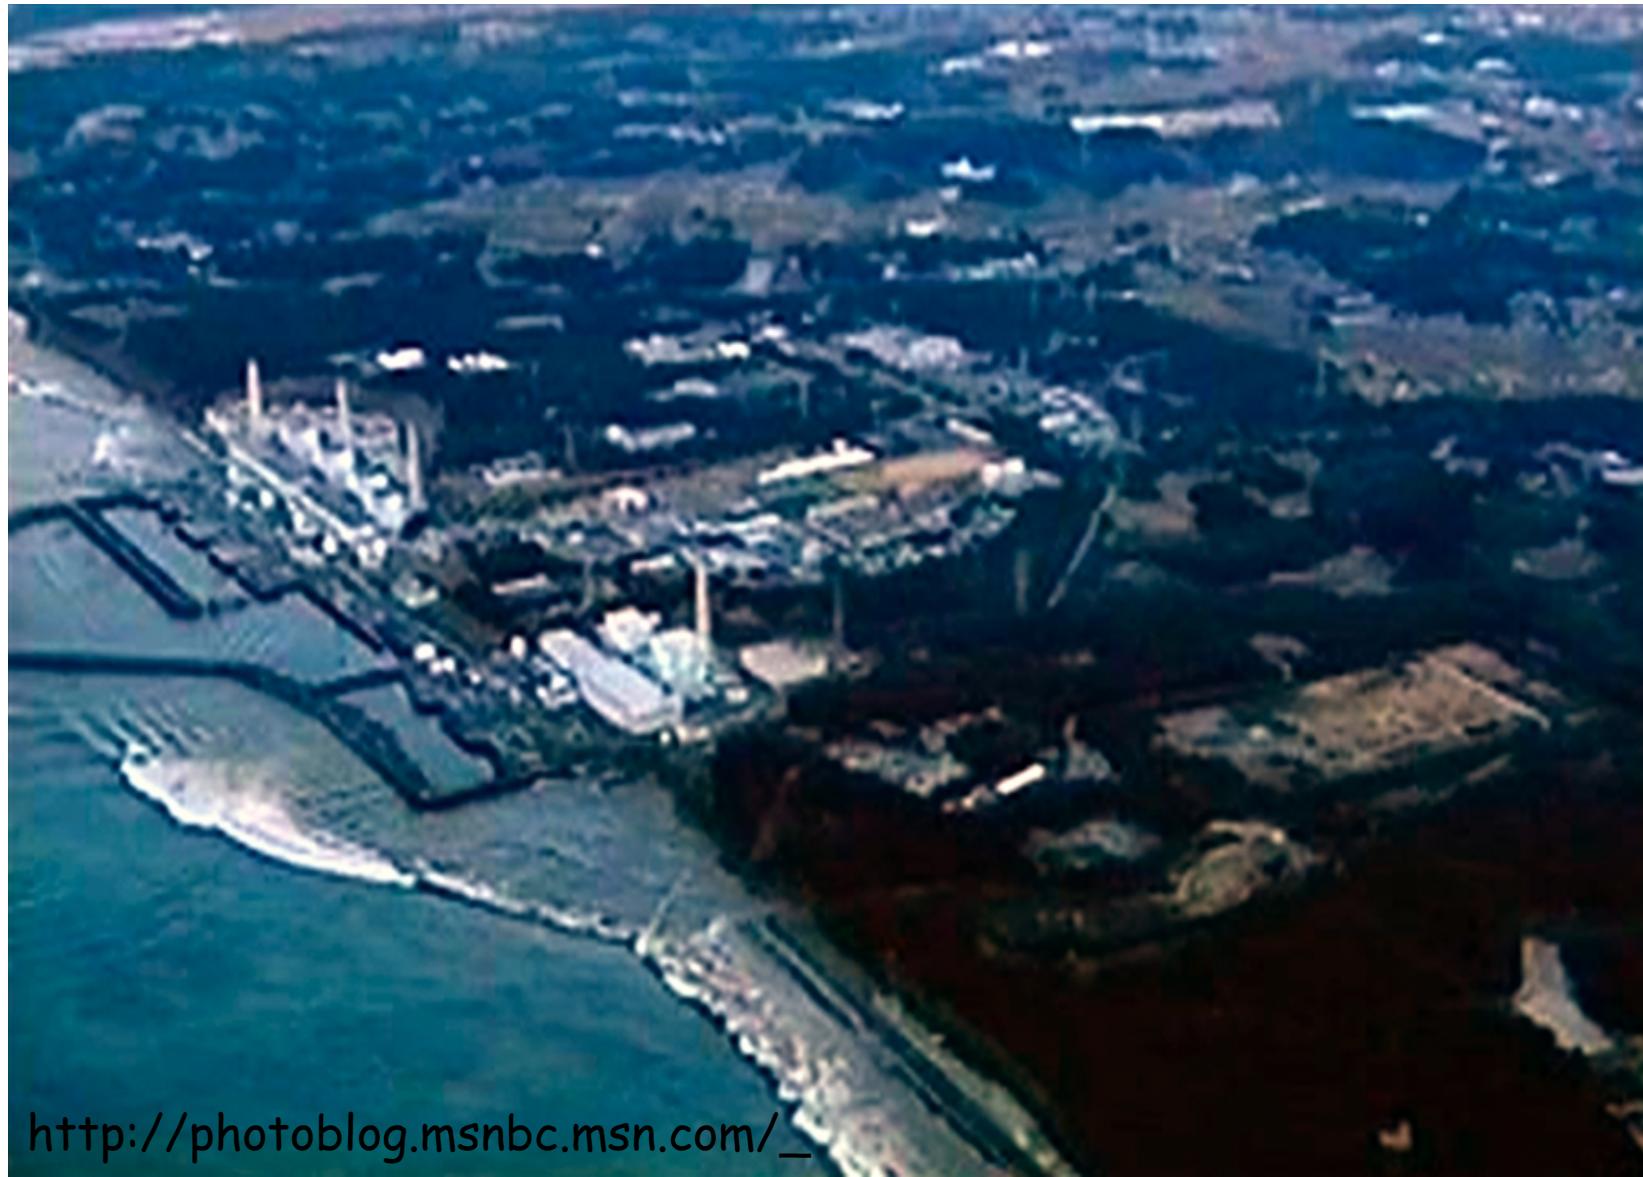
巨大津波 10-15 m > 設計時想定 6 m

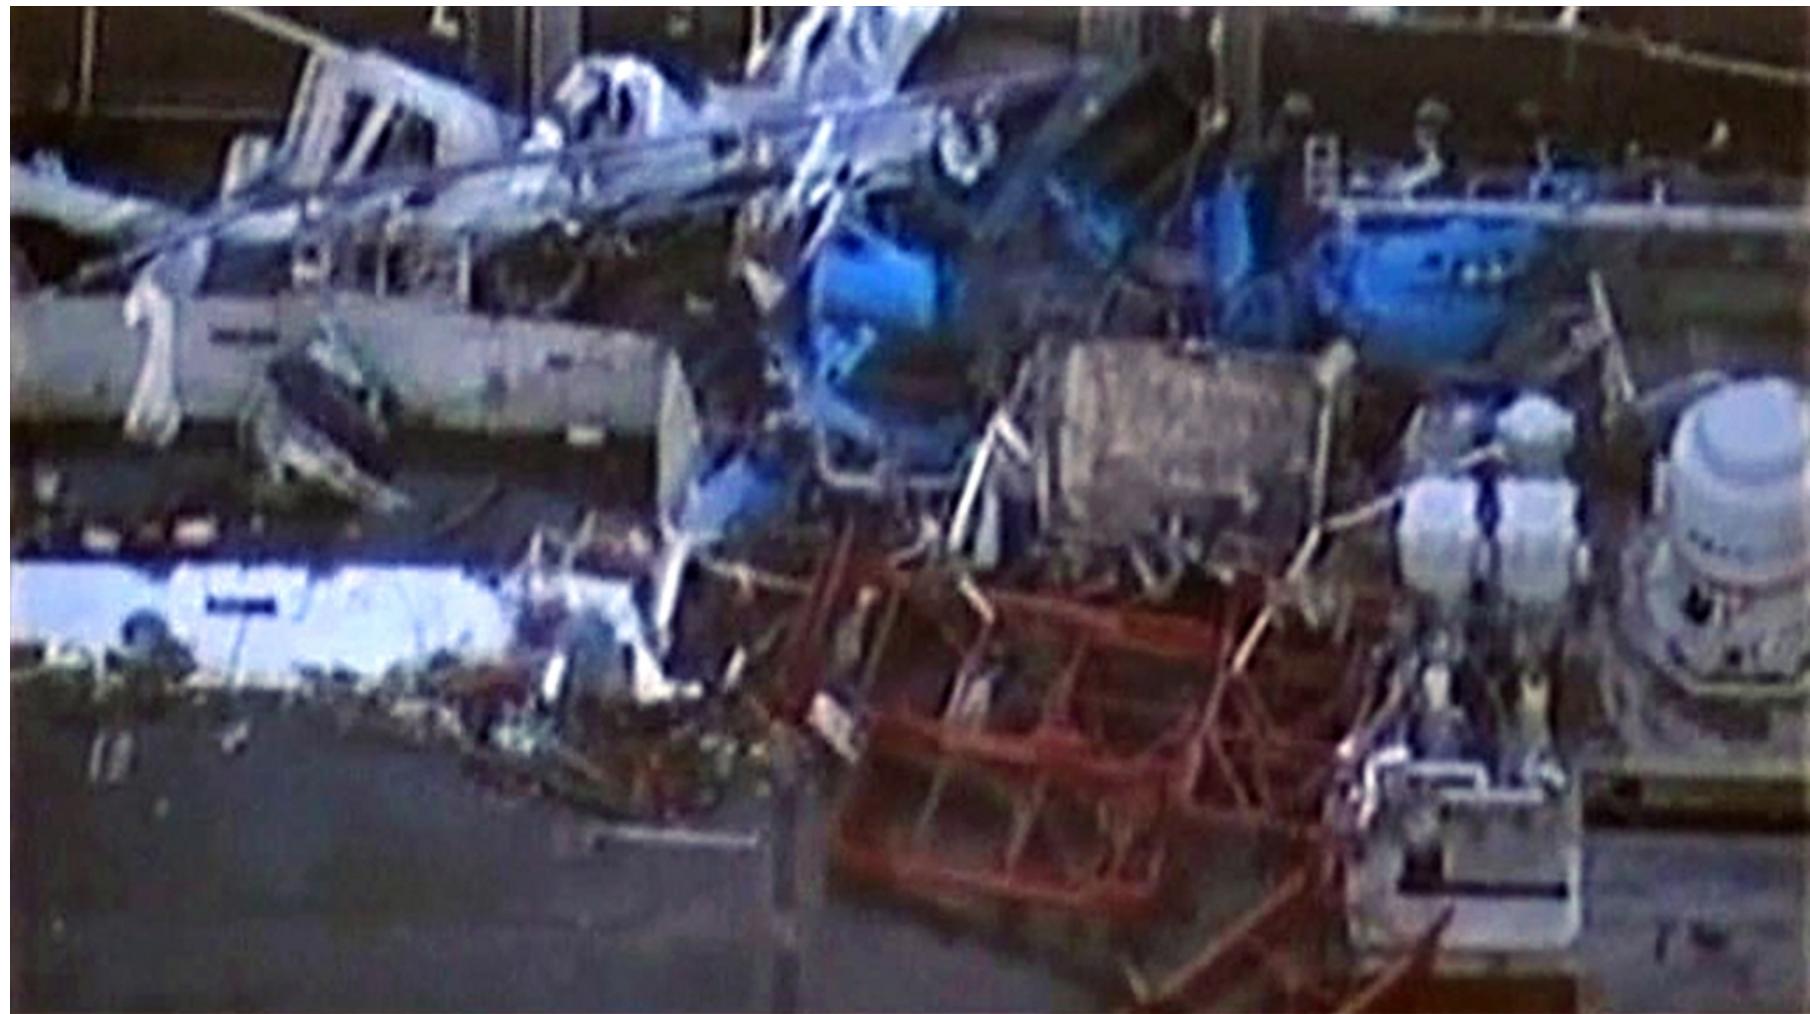
非常用電源の故障

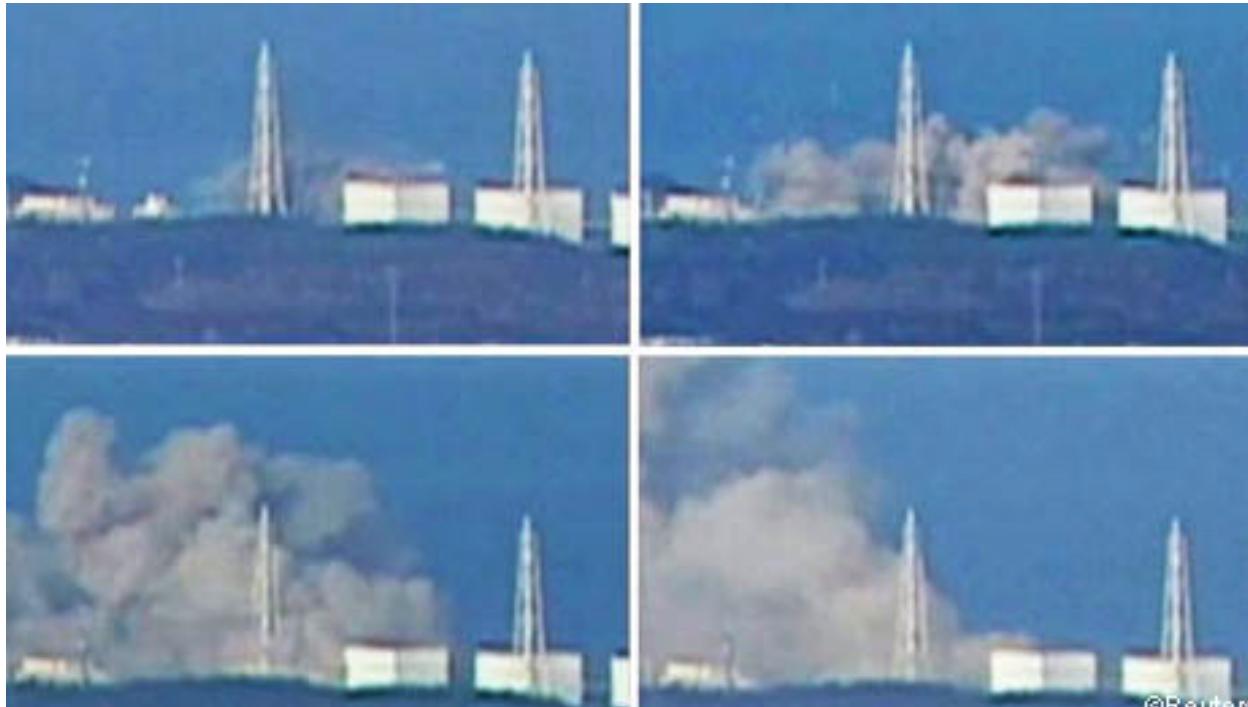
Unit 1 Explosion

1号機 水素爆発 (画像:ロイター)

建屋の上部コンクリート部分が破損され鋼鉄の骨組みのみが残されている

- ・ 発電所の停電から24時間後に爆発。最初のベントの5.5時間後
- ・ 最初の爆発はおもに横向きで、目に見える破損物が100m以上の高さまで飛んだ。
- ・ デザインから予測されるように燃料補給部周囲のパネルが吹き飛ぶ
- ・ 建物の骨格はほぼ無傷
- ・ 原子炉部の破損状況は不明
- ・ 発生した雲は主にゴミやコンクリートのようだ
 - 核分裂生成物質の放出量はベントよりも同量か少ないように見受けられる(下の公表値参照)
- ・ 原子炉圧力容器と原子炉格納容器は圧を保ったようだ(4/3測定値参照)
- ・ 爆発は亜音速であったようだ
 - Relatively low concentration <10-15% of H₂ at time of explosion so DDT did not occur.

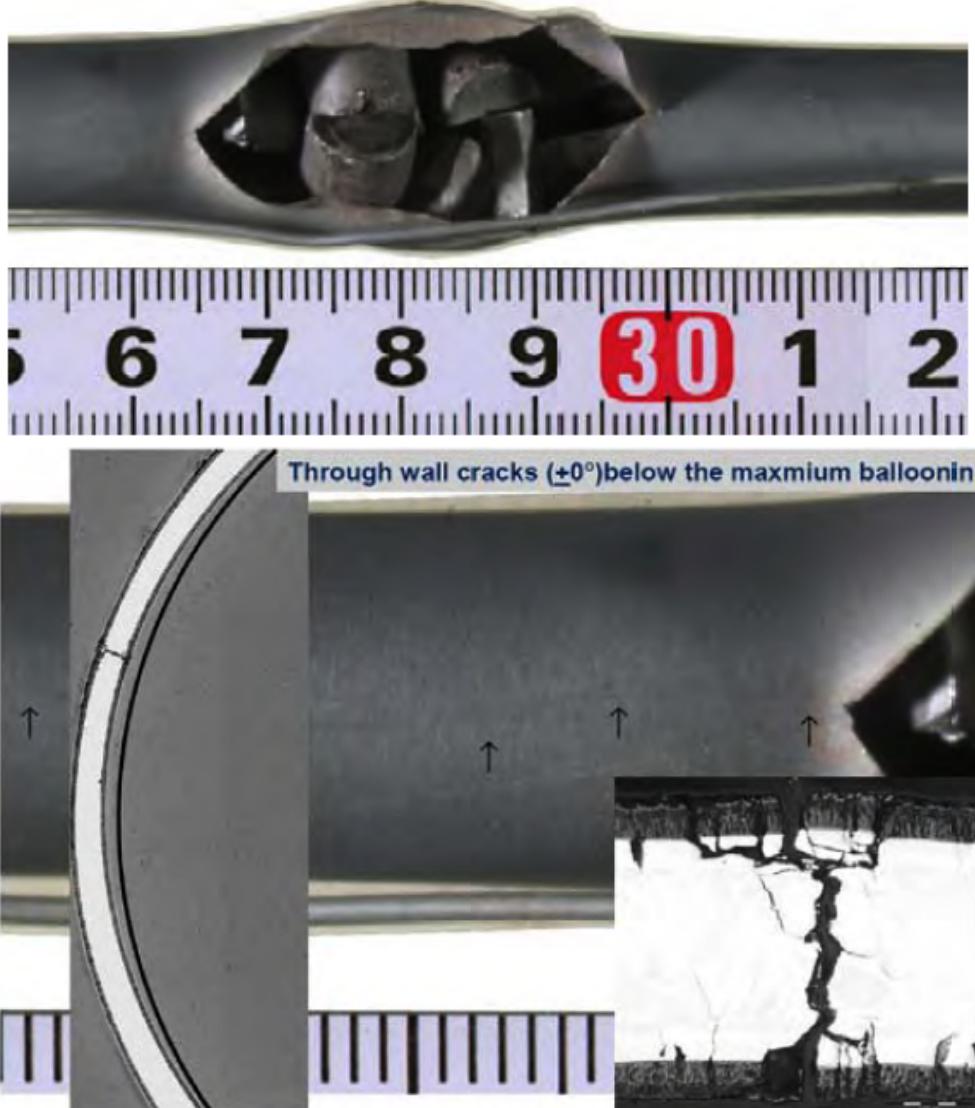
ジルコニウム燃料被覆管の破裂(温度900°C以上) Cracking and Rupture of Zr Clad

Peak cladding temperature of 900 C.

Internal pressure of FP gases creates hoop stress on clad.

Through wall cracks.

Rupture of cladding → releasing FP gases and fuel

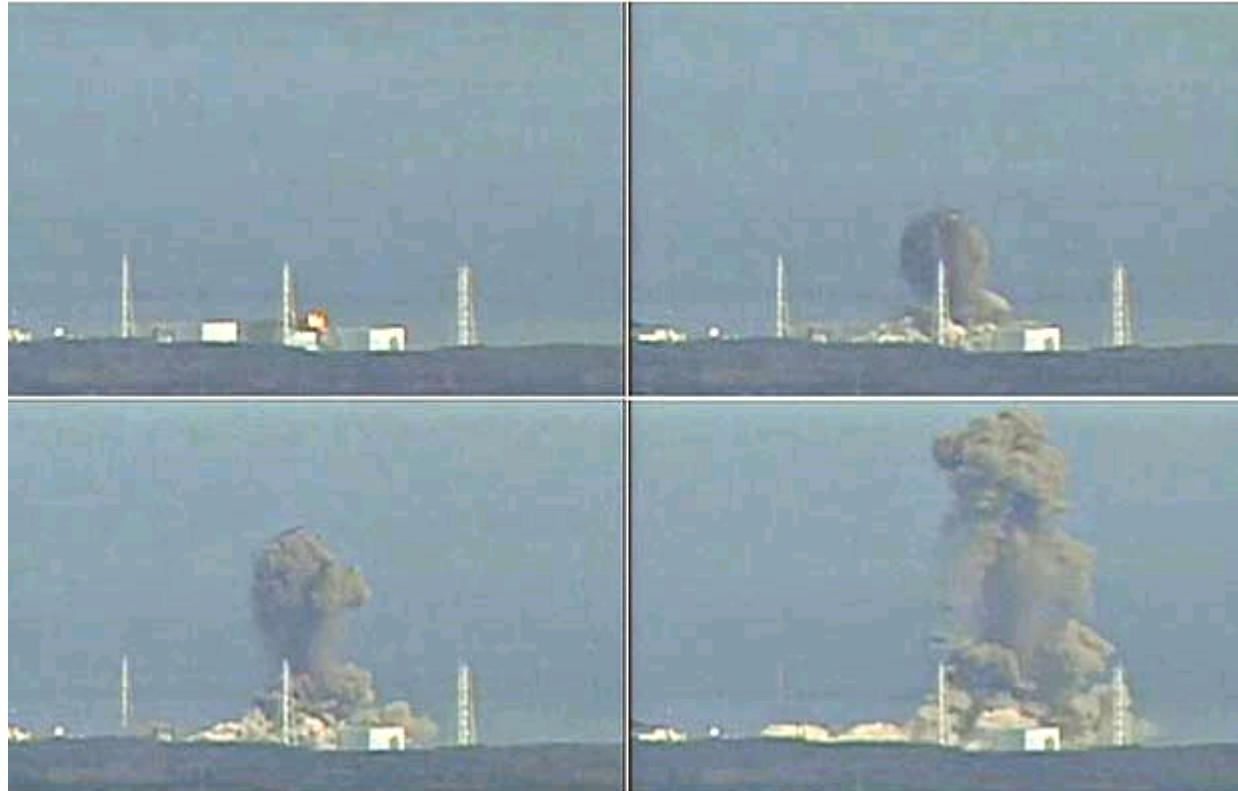
3号機での水素爆発

9:37:00	14.40	66.82	Radiation dose at site boundary around main entrance exceeds limit value.
3号機水素爆発	11:01:00	14.46	68.22	Explosion destroys Unit 3 refueling bay superstructure, panels, extensive damage. Visible flash at beginning of explosion. Large dark cloud at least 500m high, fragments possibly impact unit 2 and 4 reactor buildings. 11 workers injured.

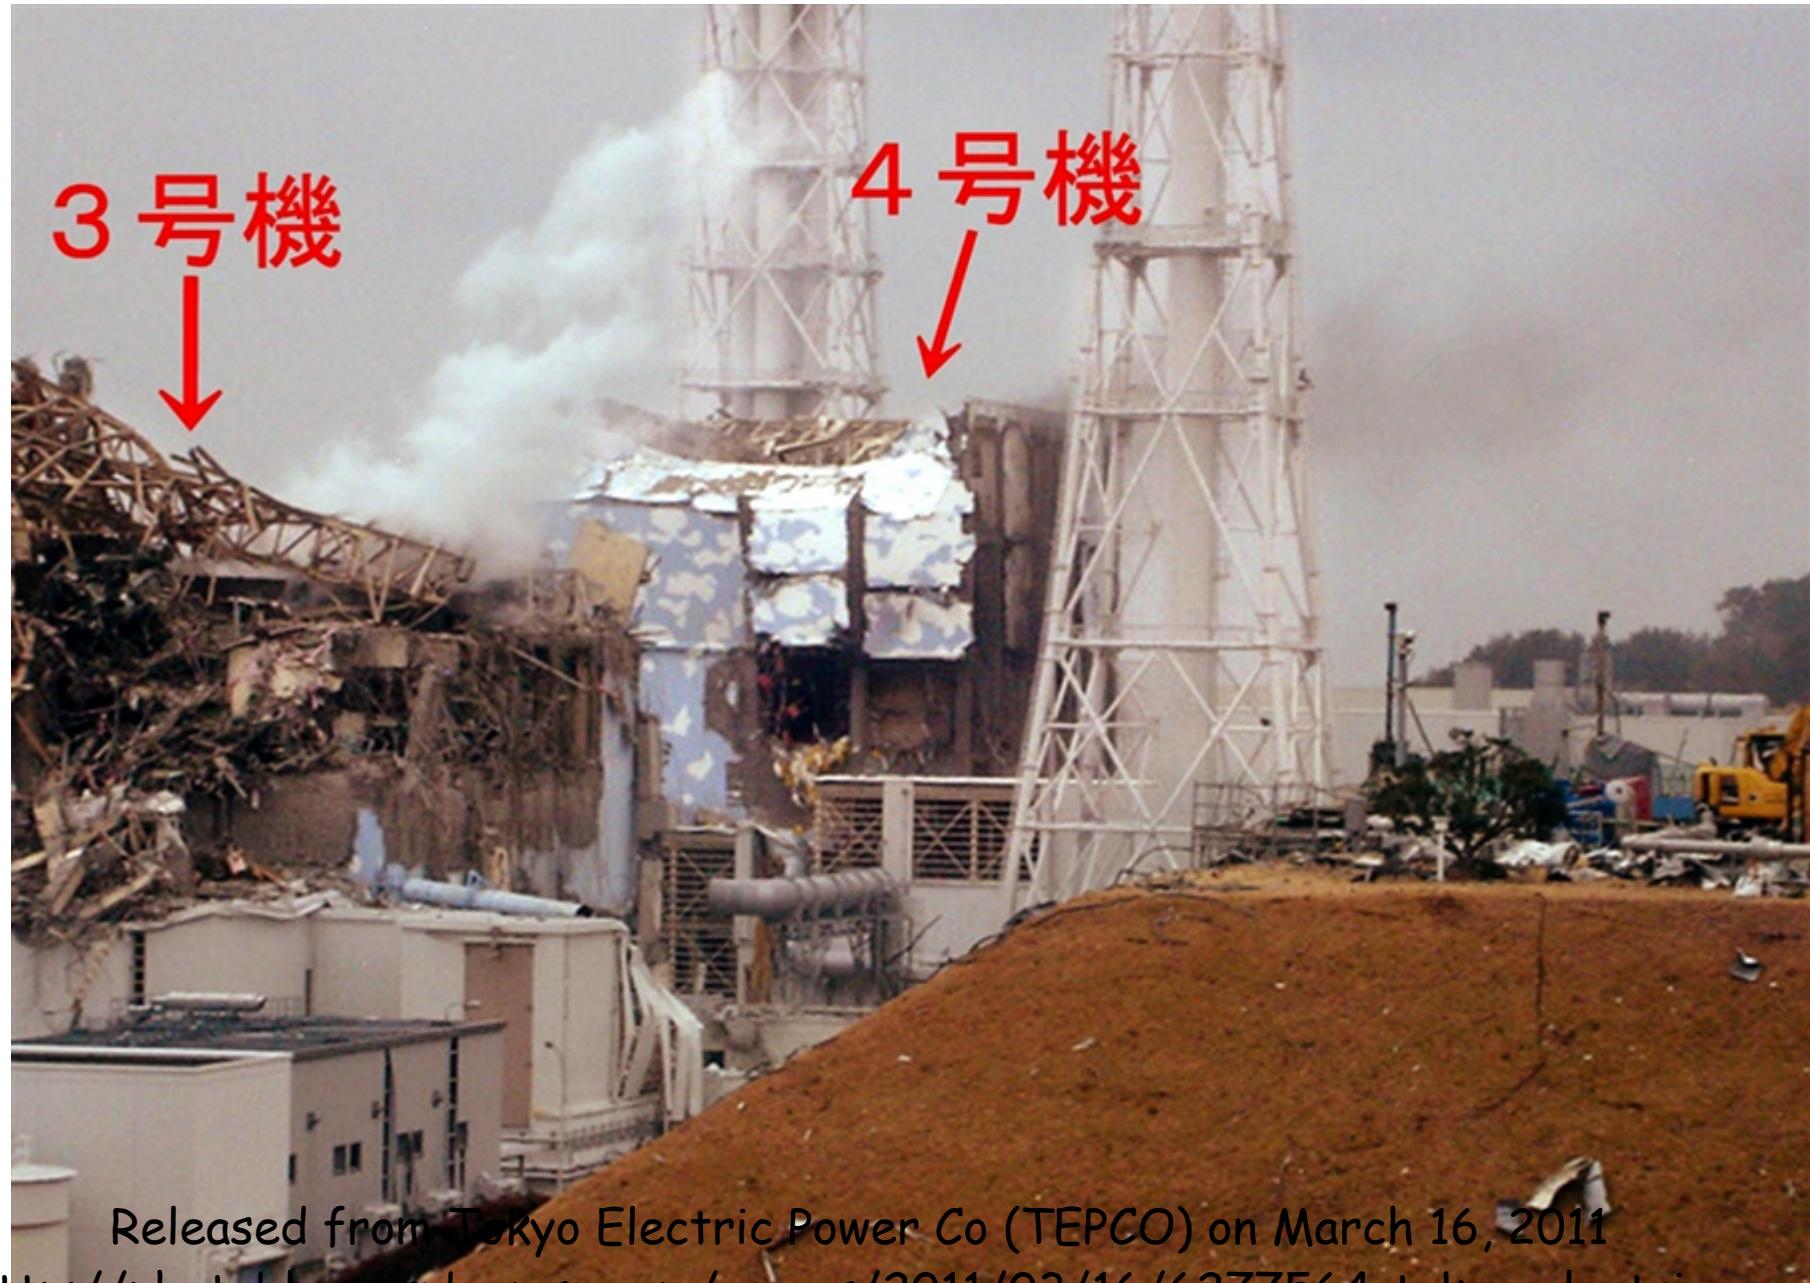
4号機の状況

- どのように破損が起こったか不明
 - 火事 → 爆発 もしくは 爆発 → 火事
 - 一回の爆発それとも複数？
 - 何が燃えたか？
 - ジルコニウム合金自体？
 - 蒸気との反応で発生した水素？
 - 燃料交換部にある他の物質？
 - 冷却系からもれた水素？
- 爆発により多大な損傷
 - 多数のパネルが吹き飛んだことは相当量の水素が溜まっていたことを示す

Released from Tokyo Electric Power Co (TEPCO) on March 16, 2011

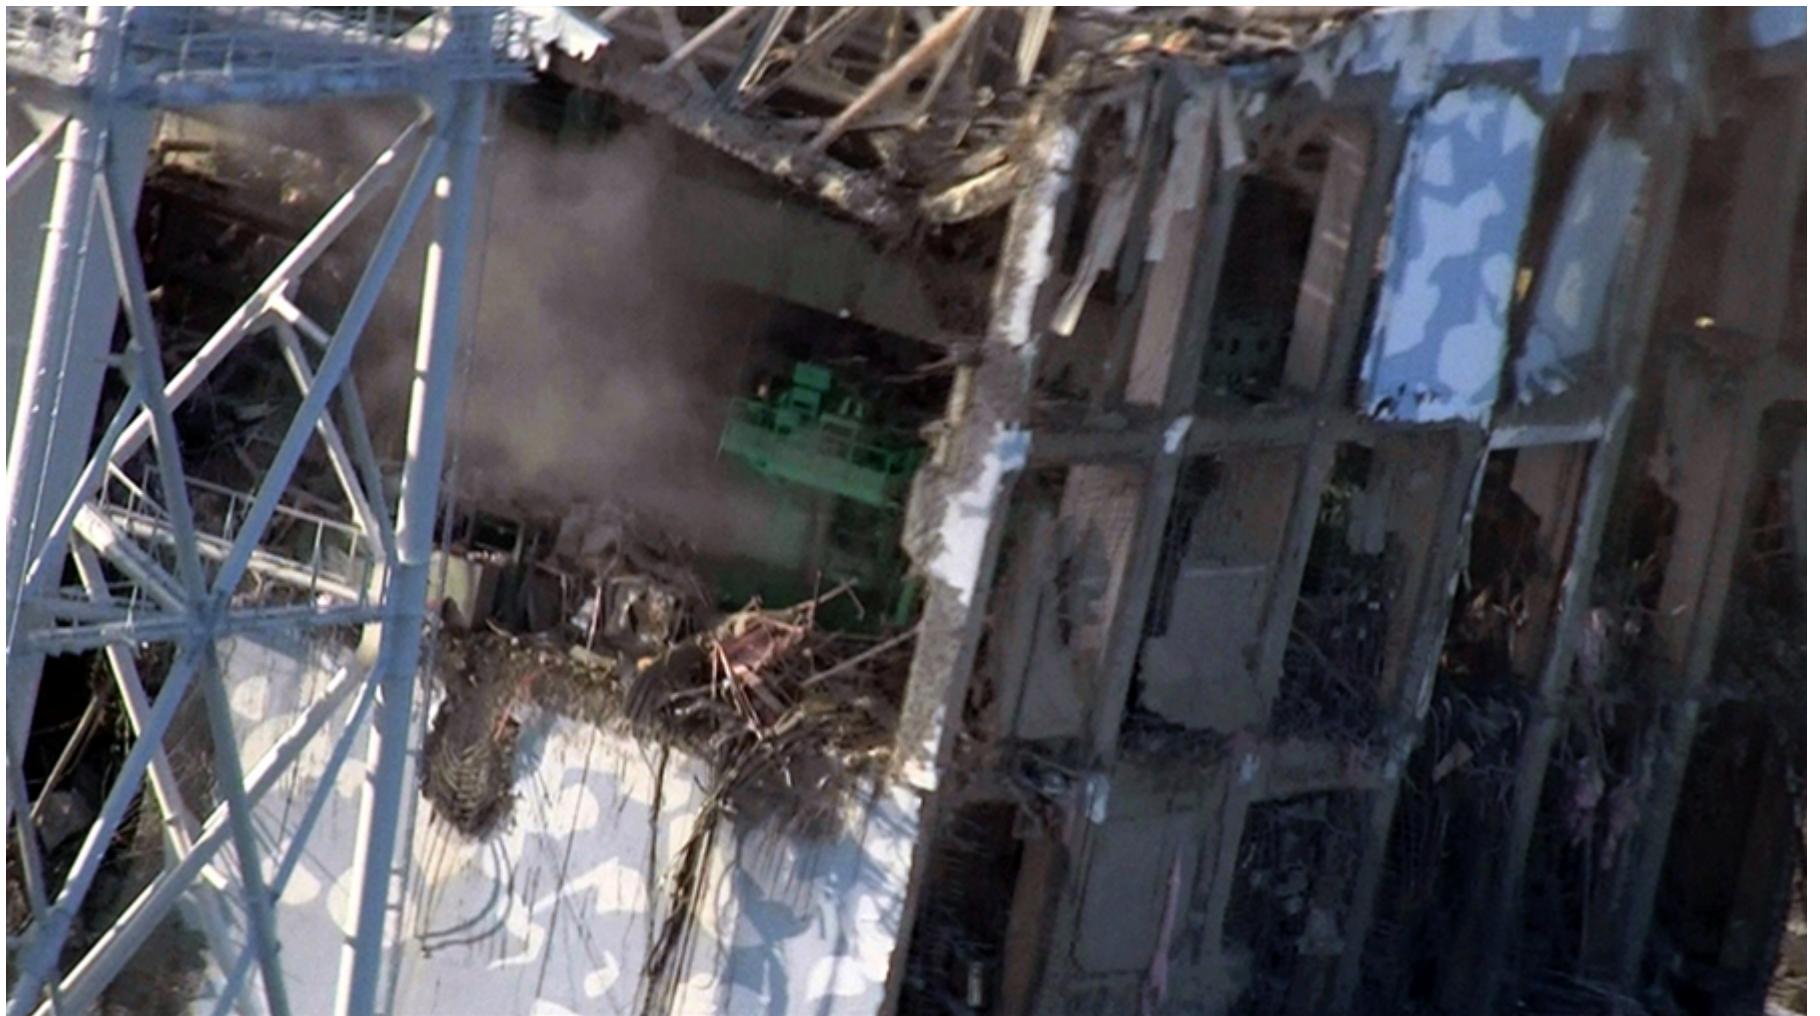
March 17, 2011 Tepco image of damage to Unit 4.

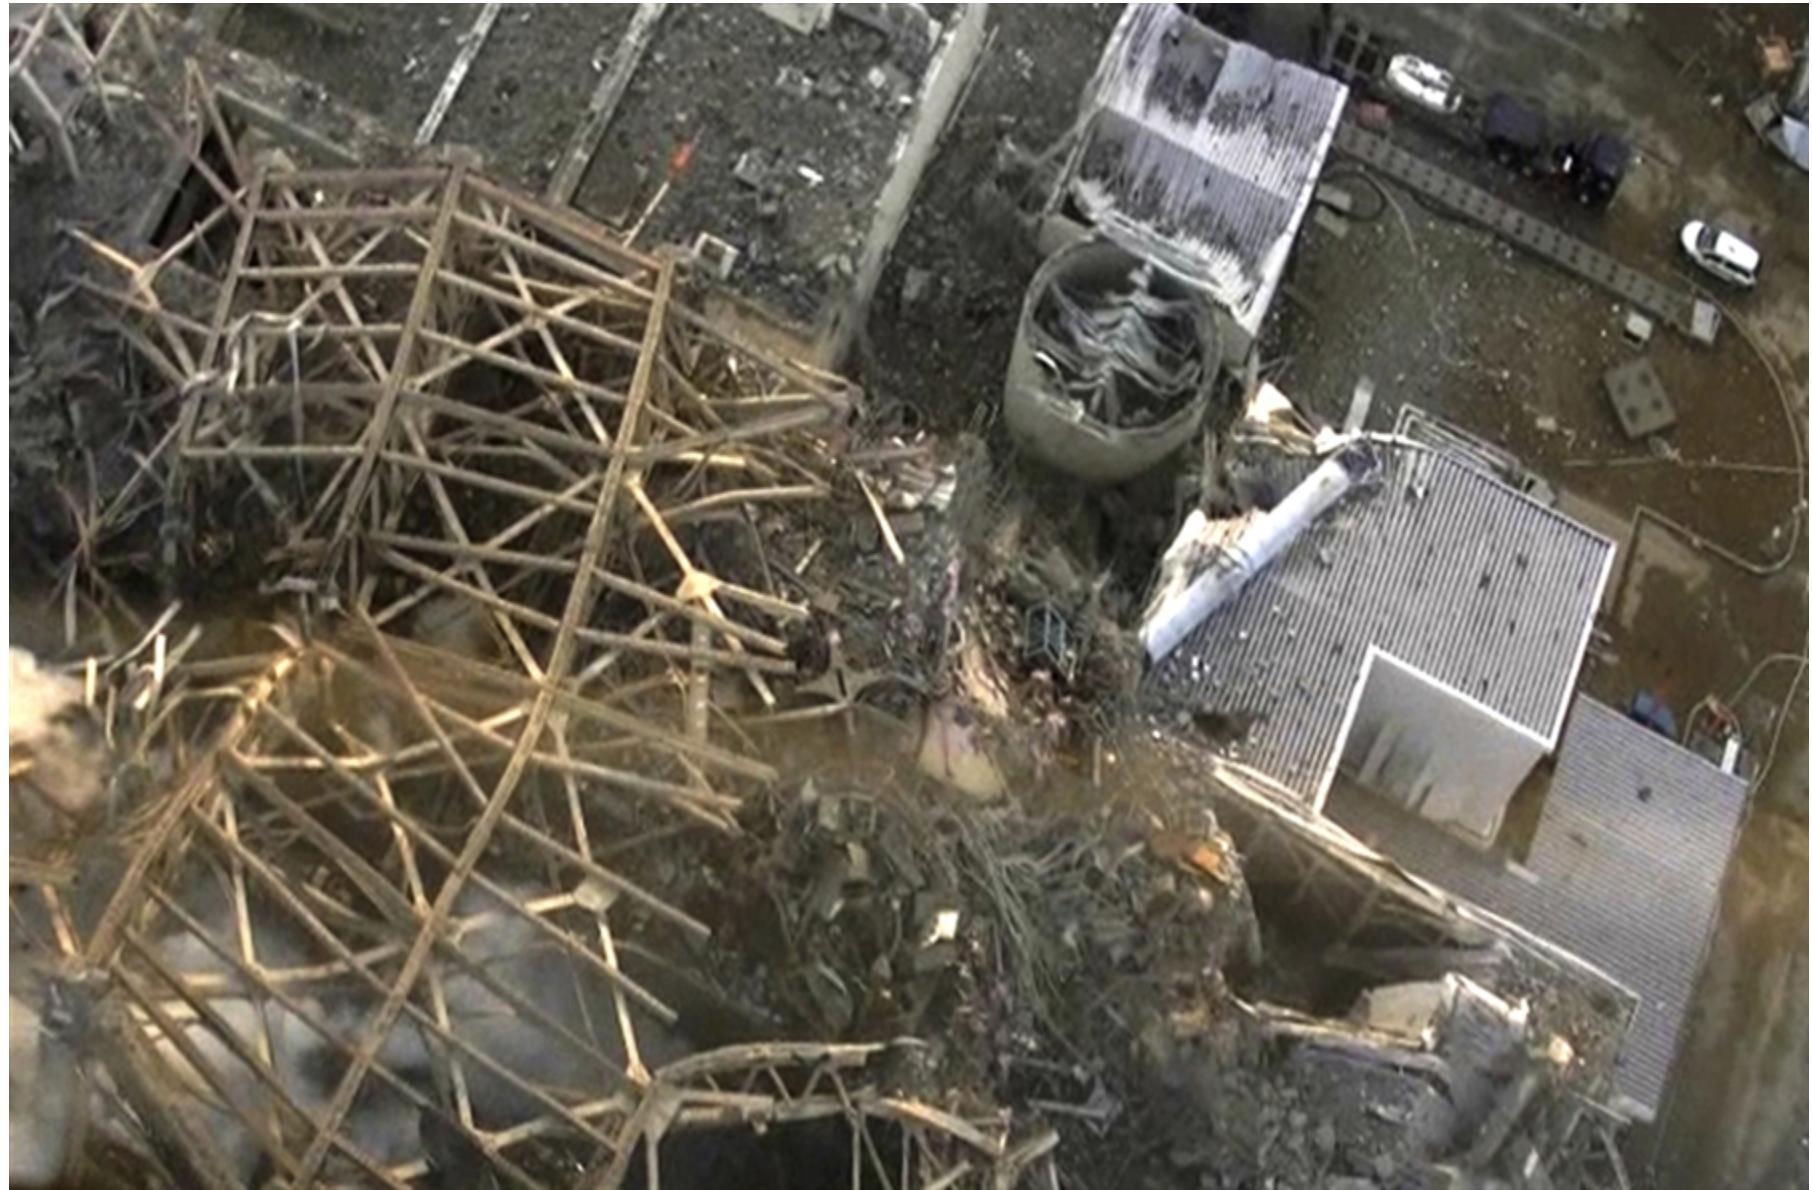
Frame from video taken on March 16 by SDF helicopter overflight. Unit 3

- 電源喪失の32時間後、ベントの6時間後に爆発
- 目で見える炎の発生
 - Occurs as panels blow out, probably luminosity from entrained debris
- 300-500m以上、ものが飛びあがる
- 50km以上の距離から音が聞こえていた
- パネルや骨格は外向きに吹き出され、屋根は下に落ちる
 - Debris in pool - not clear where crane structure is now located
 - Damage to turbine building roof may be associated with building fragments or equipment hurled out of refueling bay
- Concrete beams and panels below refueling deck damaged
- 原子炉圧力容器と原子炉格納容器は圧を下げている(4/9現在)

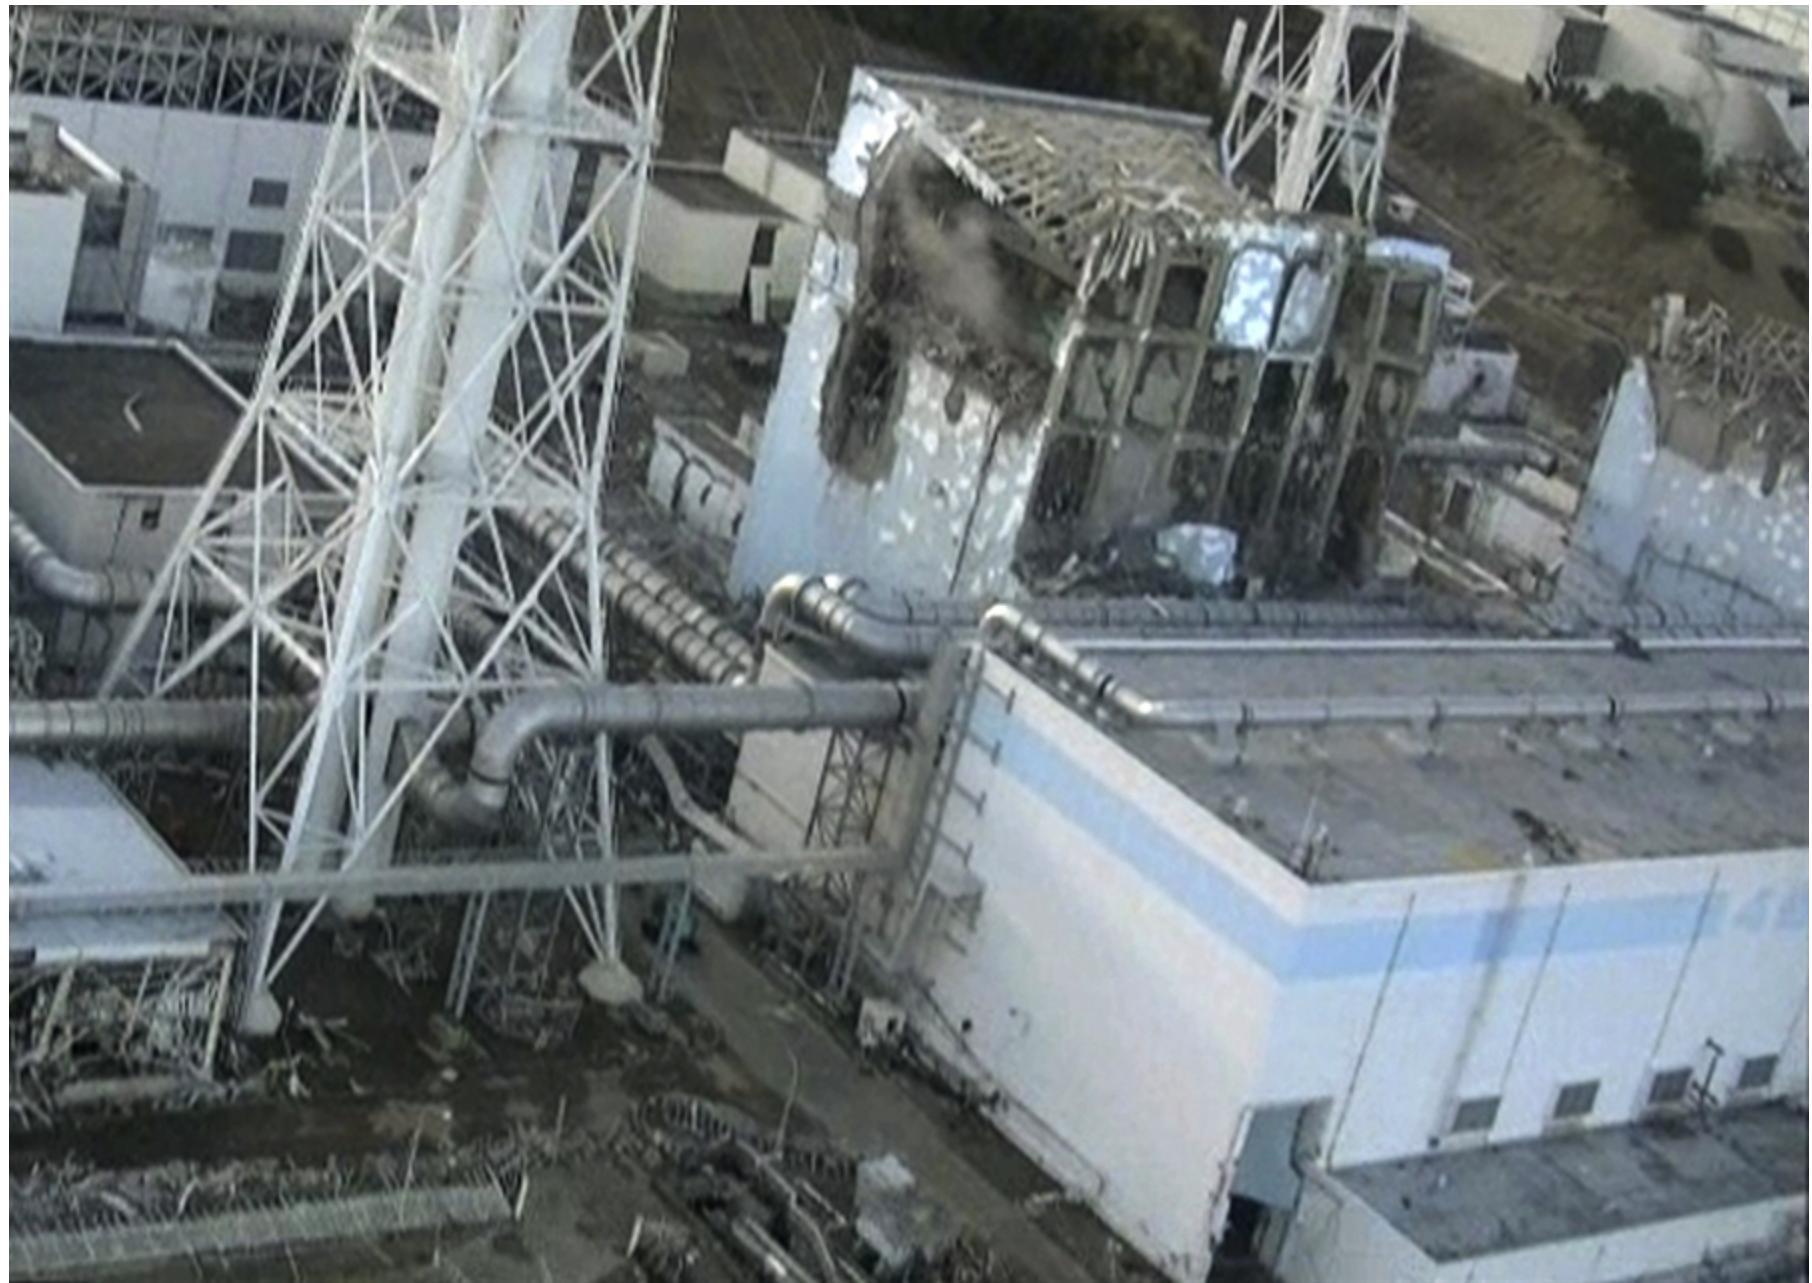
Frame from video taken from SDF helicopter overflight. Unit 4

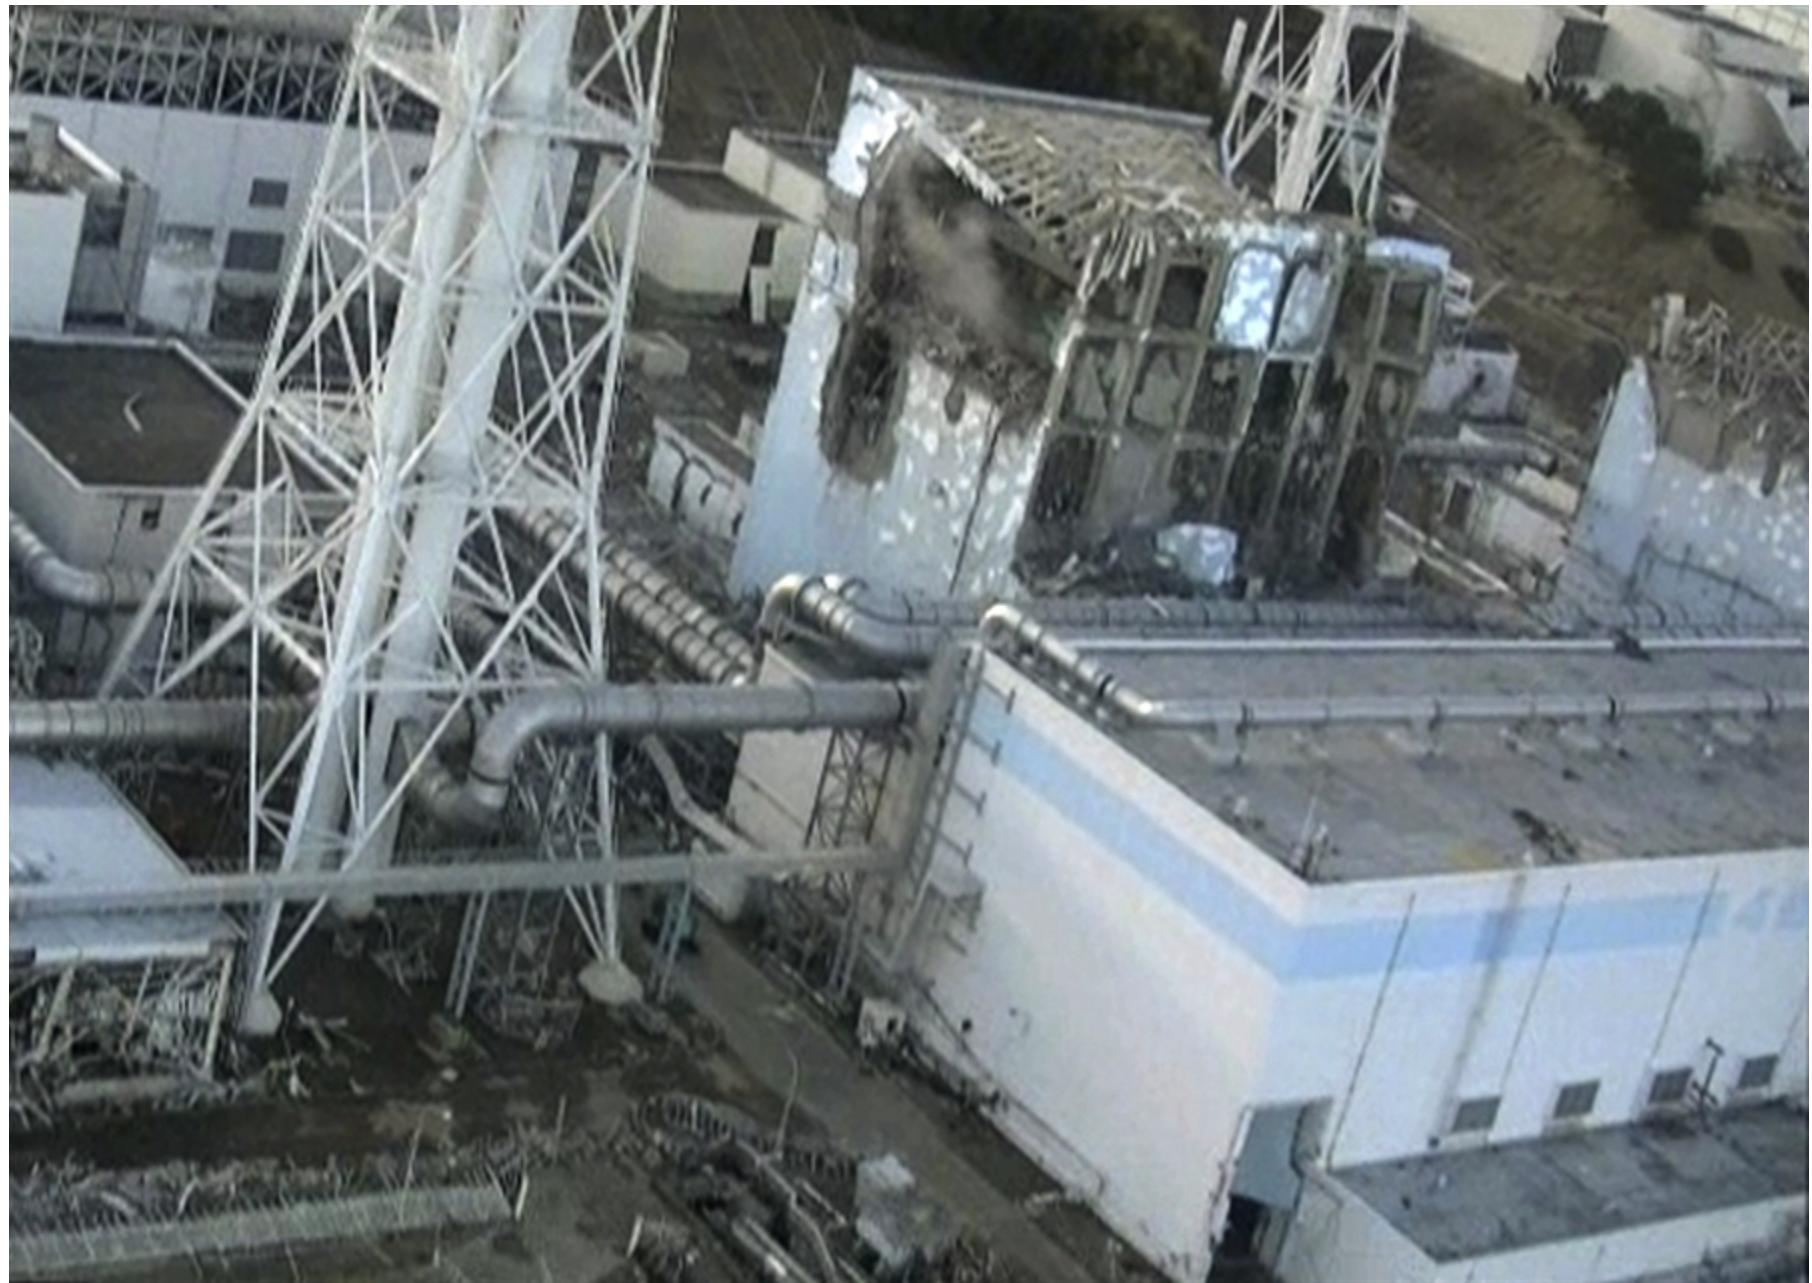
Frame from video taken from SDF helicopter overflight. Unit 4

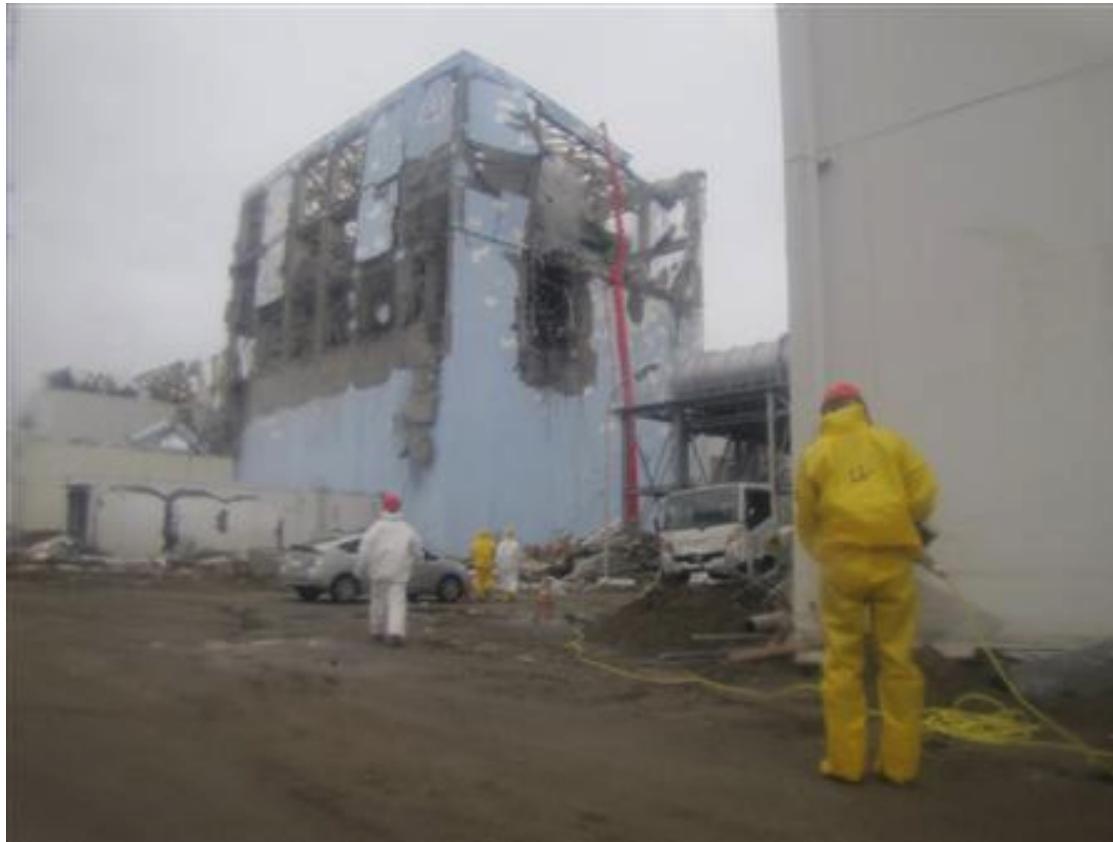
使用済み燃料の冷却 第4号機

2011年3月25日(金)				
	6:05:00	25.25	327.28	第4号機使用済み燃料置場への、冷却管からの海水注入(10時20分まで)
	10:30:00	25.44	331.70	第2号機使用済み燃料置場への、海水注入(12時19分まで)
	13:28:00	25.56	334.67	第3号機上への水の噴霧(16時00分まで)

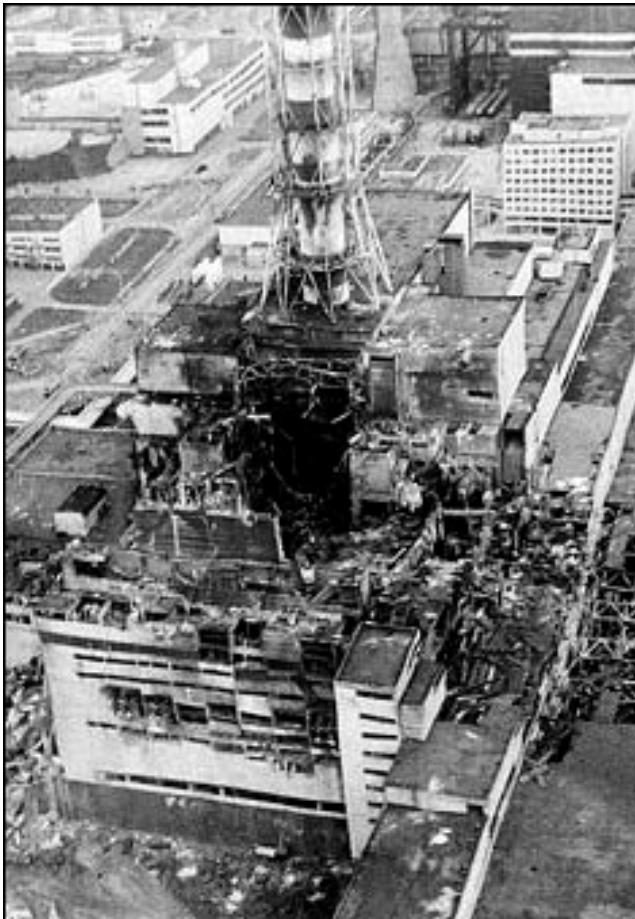
切尔诺贝利事故

- 1000 Mwe RBMK-type reactor:
Graphite-moderated, water-cooled, no containment structure or pressure vessel
- 26 April 1986
- Criticality accident caused by multiple factors including poor design, willful disregard of regulations, ignorance of reactor physics by operators
- Explosion and fire completely destroyed reactor, created large plume of contamination
- Required resettlement of 350,000 people
- 600,000 "liquidators" involved in cleaning up site and building containment structure.
