The Crisis at Fukushima Dai-ichi Nuclear Power Plant

Prof. Joseph E Shepherd
Aerospace and Mechanical Engineering
California Institute of Technology
Pasadena, CA

April 2011

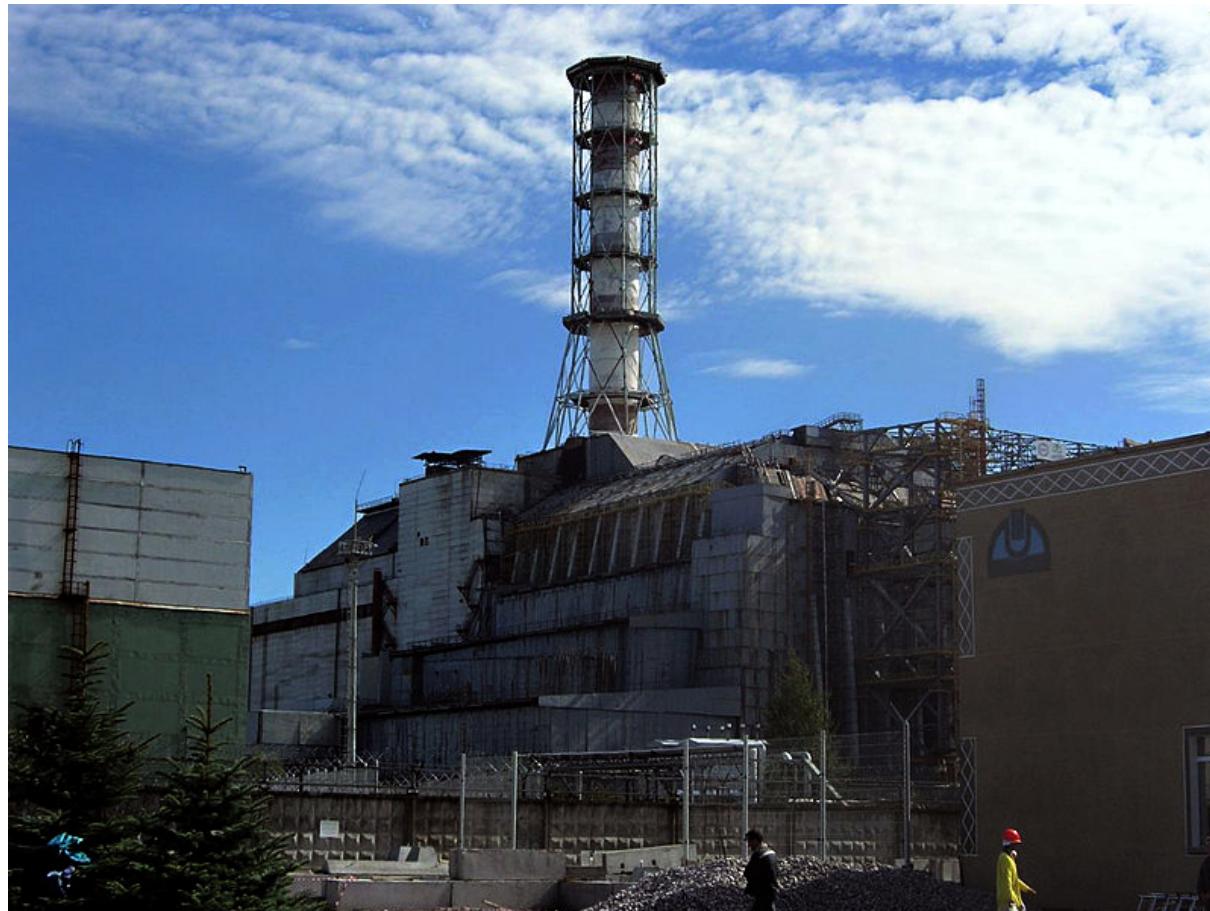
石棺

- Remaining molten core materials (~200 tonne) enclosed in concrete "sarcophagus"
- 400,000 m³ of concrete and 7,300 tonnes steel
- Deteriorating and cannot be repaired.
- 100-yr cover building to be installed in 2013

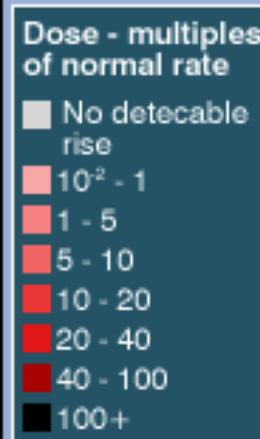
INCREASED RADIATION DOSE ACROSS EUROPE - 3 MAY 1986

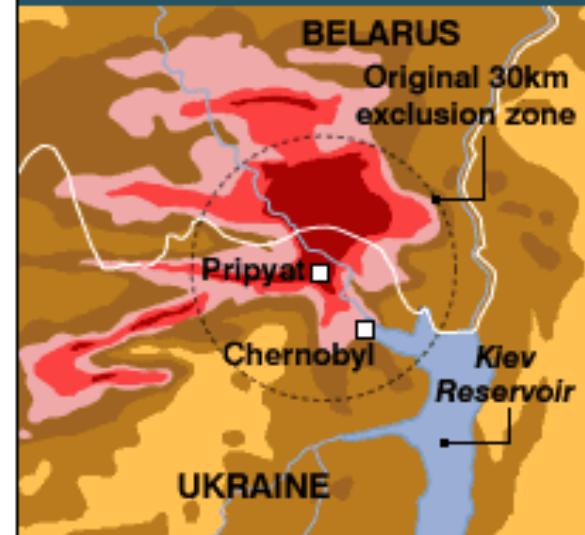
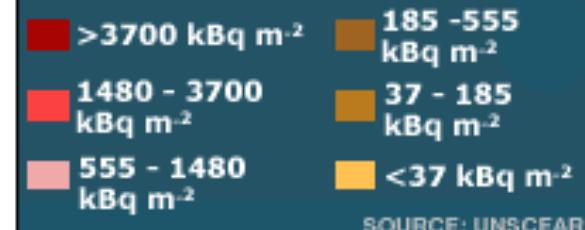
CAESIUM DEPOSITION
